Manhole Inspection Summary

Manhole # S21G1_011MH

Location Address: **2519 arbuton av** Cross Street: **hollins ferry rd**

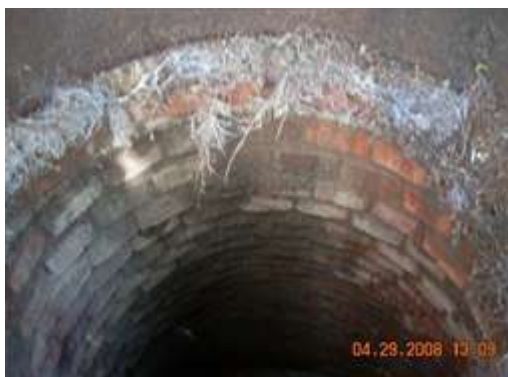
Defect 2

Manhole Type: **Terminal** Location: **Sidewalk** Ground Conditions: **Wet**
☐ Prev. Rehab Weather: **Dry** Subject To Ponding: **Sheeting**

inflow evidence from sheeting

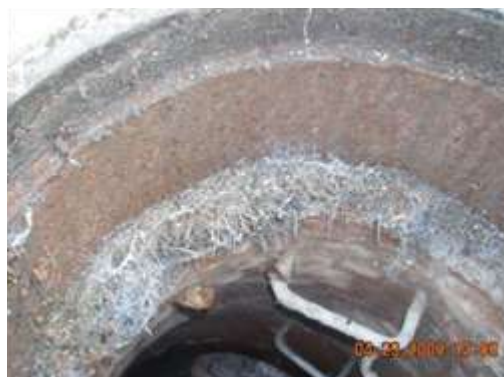
Defect 1

Frame Offset: **0** (in.) Condition: ☐ Sound ☐ Cracked ☒ **Leaks**

Corbel Material: **Brick** ☐ Parged Type: **Concentric/Eccentric**
Condition: ☒ Sound ☐ Cracked ☐ Root Intrusion ☐ Loose Brick ☐ Deteriorated
Infiltration: ☐ None ☐ Joint ☐ Cracks ☐ Mortar ☒ **Roots** ☐ Wall

root infiltration @ corbel/frame joint

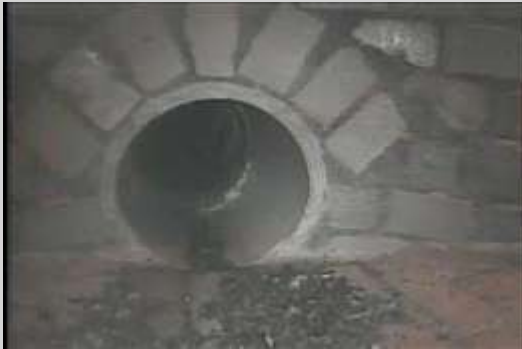
12 O'Clock Outflow

8 in. Circular Gravity Sewer
Pipe Out @ 12 O'Clock

Pipe Height: **8.4** (in.) Rod and Bar (Angled)

Pipe Material: **Clay** ☐ Pipe Lined

Invert Depth: **7.70** (ft.) Flow Characteristics: **None**

Infiltration: **None** Pipe Seal Cond: **Sound**
